The Material Compatibility Between Spray Foam Insulation and Henry Blueskin SA (Asphaltic-based Peel and Stick Air Barrier)

White Paper

This report summarizes a root cause analysis investigation into the reported SPF material compatibility complaints with Henry Blueskin SA (Asphaltic-based Peel and Stick Air Barrier).

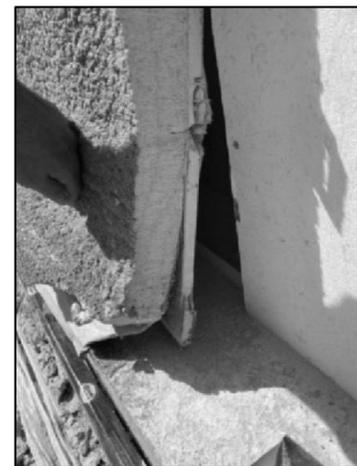
In late 2022 both Henry Company technical service representatives and Carlisle Spray Foam Insulation representatives noticed a sudden rise in complaints from spray foam applicators across Canada. These complaints ranged from the residential sector to the commercial sector where installed spray foam was either: popping away from studs, curling sheet metal substrates, or causing Blueskin TWF or Blueskin SA to peel away from the substrate as well as a peeling from the polyethylene side of the membrane (Figure 1).

Figure 1. Shrinking foam causing Blueskin TWF to peel from exterior glass faced gypsum.

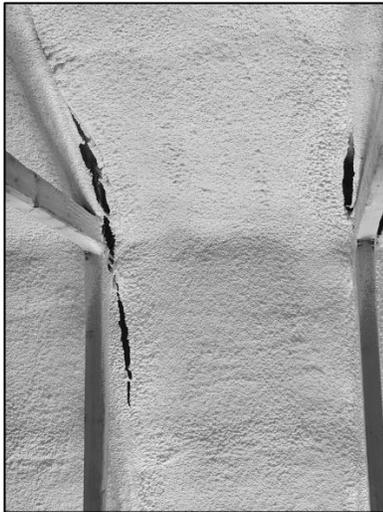
Figure 2.

Figure 2 below shows the impact of the foam's contracting forces exceeding the adhesive strength due to

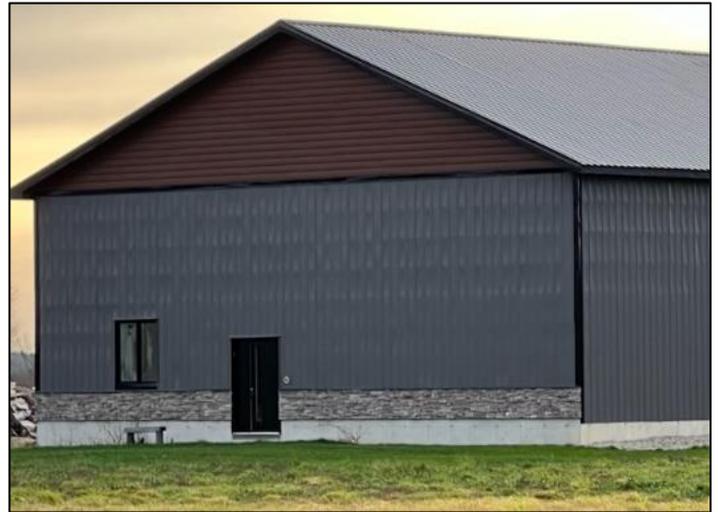
Figure 3.

compromised dimensional stability, and Figure 3 shows the secondary impact on the exterior cladding with a deleterious “oil can effect”.

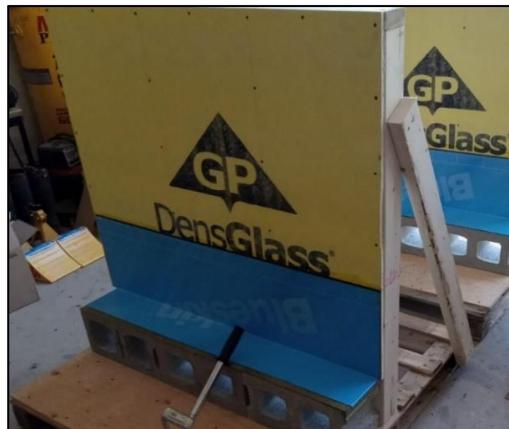
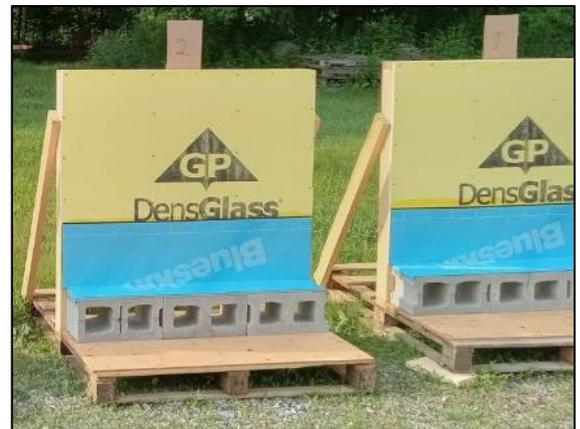
CSFI constructed two identical block walls (Figures 4 & 5) with exterior gypsum to replicate typical real-world applications of asphaltic peel and stick membranes. Both walls were primed with Henry BAKOR Hi-Tac Adhesive 3.5L prior to the application of Blueskin SA. The walls were placed outside, exposed to the elements beginning May 27, 2023, until June 19, 2023, in Eastern Ontario, Canada. These walls experienced typical summer project site conditions for temperatures, day light, and rainfall. On June 19, 2023, the walls were sprayed with SealTite One.

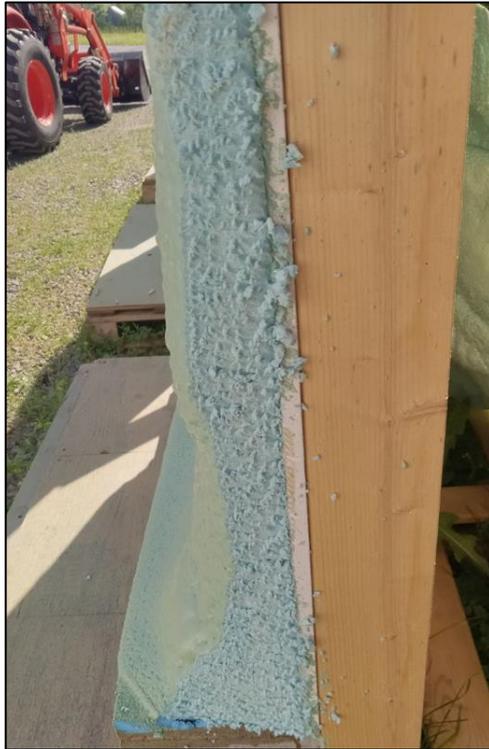
To eliminate any forces that would prevent the foam from shrinking, CSFI cut off the edges of the foam which would have wrapped around the back side of the wall. The extra foam wrapped around could hold the foam in place by adhering to the back side of the gypsum and wood framing.

Figure 6. Day 1 SealTite One applied to test walls with sides trimmed

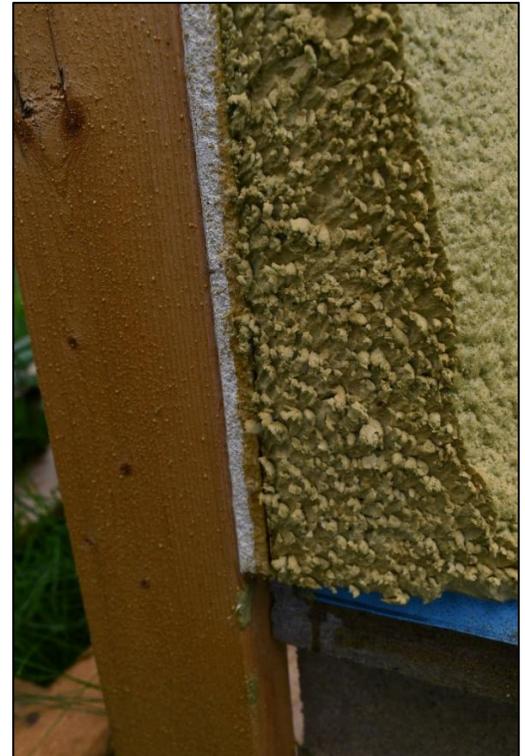
Figure 7. SealTite One with colour faded by UV exposure after approximately 3 weeks.

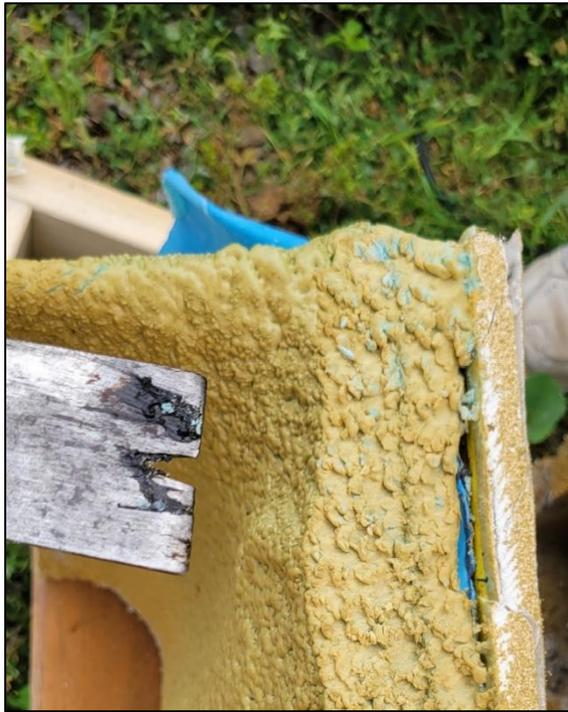
Figure 8 shows no observable gaps between the spray foam and Blueskin SA or gaps between Blueskin SA and the exterior gypsum substrate. Attempting to separate the foam from the substrate with a prybar caused gypsum to break apart indicating good adhesion of Blueskin SA to the gypsum (Figure 9).

Figure 8. First attempt to remove SealTite One from exterior glass faced gypsum. Prybar shows bitumen intact.

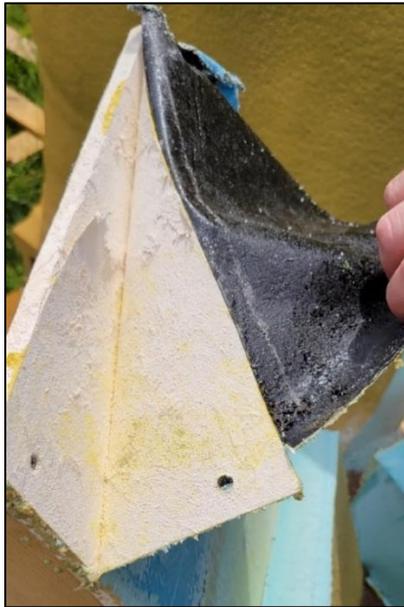
Figure 10. Attempts to pull Blueskin SA away from the gypsum substrate shows excellent adhesion. Adhesion failure occurred between the fiberglass facer to the gypsum.

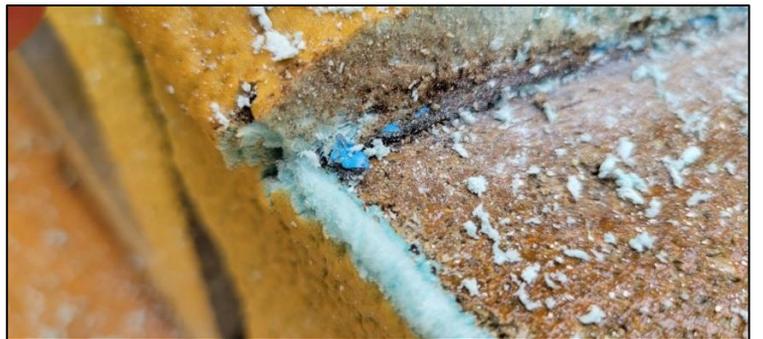
Figure 12. No cupping, curling, or warping after 3 weeks. SealTite One is flat. Blueskin SA is well adhered to CMU.
